# 苗栗縣大湖鄉雅悠圳路改善工程生態檢核及生態調查研究

## Ecological Inspection and Ecological Investigation Research on the Improvement Project of Yayou Creek Road in Dahu Township, Miaoli County

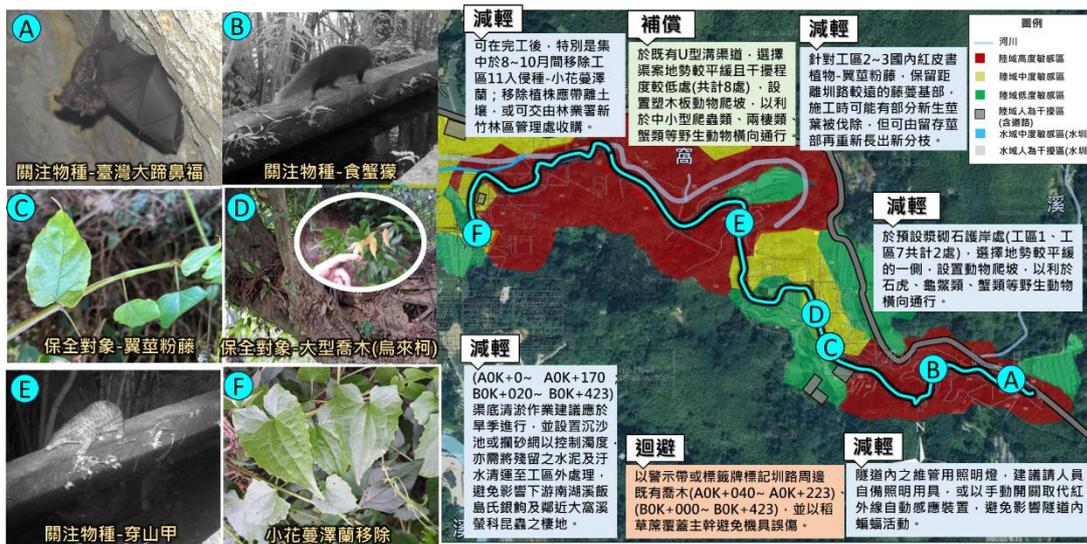
圖1 苗栗縣大湖鄉雅悠圳路改善工程

科昆蟲之棲地。(3)減輕:隧道內維管用照明燈,建議以手動開關取代紅外線自動感應裝置,避免影響隧道內蝙蝠活動。(4)減輕:應於預設砌石護岸處選擇地勢較平緩區域設置動物爬坡及板橋,以利於石虎、食蟹獾等中小型野生動物橫向通行。(5)減輕:完工後建議於8~10月間移除小花蔓澤蘭,並交由林業署新竹分署收購。(6)減輕:保留莖莖粉藤基部,避免施工時部分新生莖葉被伐除,並可利於由留存莖部再重新長出新分枝。(7)減輕:選擇渠案地勢較平緩且干擾程度較低處,設置動物爬坡,以利於爬蟲類、兩棲類、蟹類等小型動物通行。本案生態保育措施如圖1所示。

本案於 112 年 9 月至 113 年 8 月間完成核定、規劃設計、施工、維護管理等各階段生態檢核作業。其中本案執行核定及規劃設計階段期間，經由相關圖資套疊結果發現，本工區位於石虎潛在棲地，而工區下游則鄰近南湖溪主流-飯島氏銀鮎棲地，另透過生態相關資料庫及文獻蒐集結果，亦將穿山甲、食蟹獾、臺灣小蹄鼻蝠、黃胸黑翅螢等列為本案關注種。為完善生態情資及生態保育措施，本案亦透過公公及公私協力方式，邀集苗栗農工、苗栗縣內山必落腳文化協會、生物多樣性研究所、大湖鄉公所等公部門及在地團體辦理民眾參與及現勘會議，以共同確認生態保育措施，其包括(1)迴避：以警示帶標記圳路周邊喬木，並以稻草蓆覆蓋主幹避免機具誤傷。(2)減輕：渠底清淤作業建議應於旱季進行，並設置沉沙池或攔砂網以控制濁度，避免影響下游飯島氏銀鮎及大窩溪螢

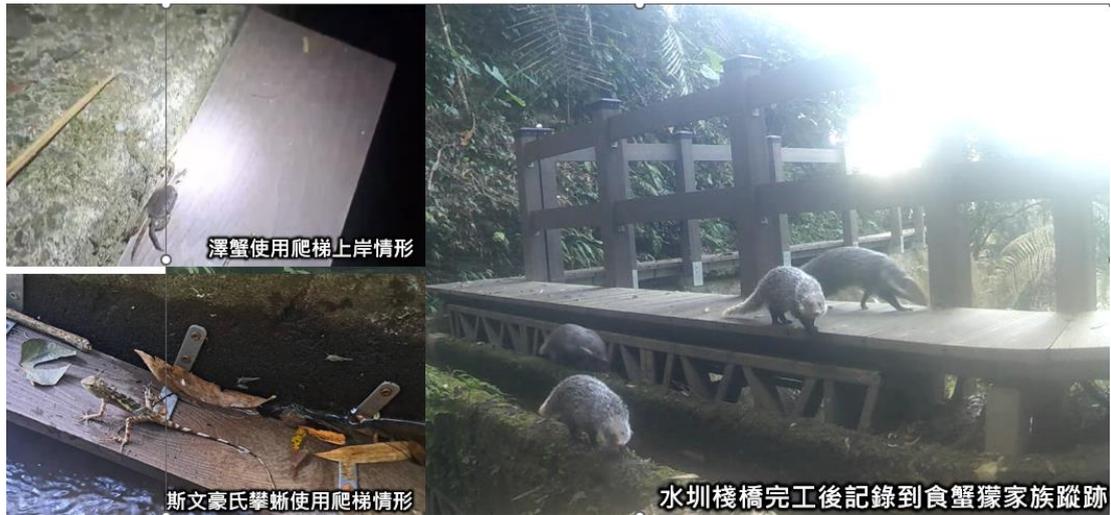
圖 2 本案完工後監測野生動物利用生態友善措施情形

另本案於113年7月執行完工後生態調查共計動物水陸域動物42科68種,植物類群則達76科149種,顯示本案於施工期間對圳路周圍棲地擾動範圍小,並完善落實施工中生態保育措施。本工程亦規劃多處動物爬坡及板橋,以利中小型野生動物橫向通行,並確保施工中應極力減少周邊地被植物開挖面積。完工後,回收圳路周邊自動相機已發有如藍腹鷓、穿山甲、山羌等野生動物活動,甚至記錄到4隻食蟹獾同時利用已完工之渡槽棧道移動。另亦發現有澤蟹利用已完工之生態爬梯上岸之記錄,顯示工程確實已維持棲地間完整性(圖2)。
